Experimental study on the behavior of segmented buried concrete pipelines subject to ground movements

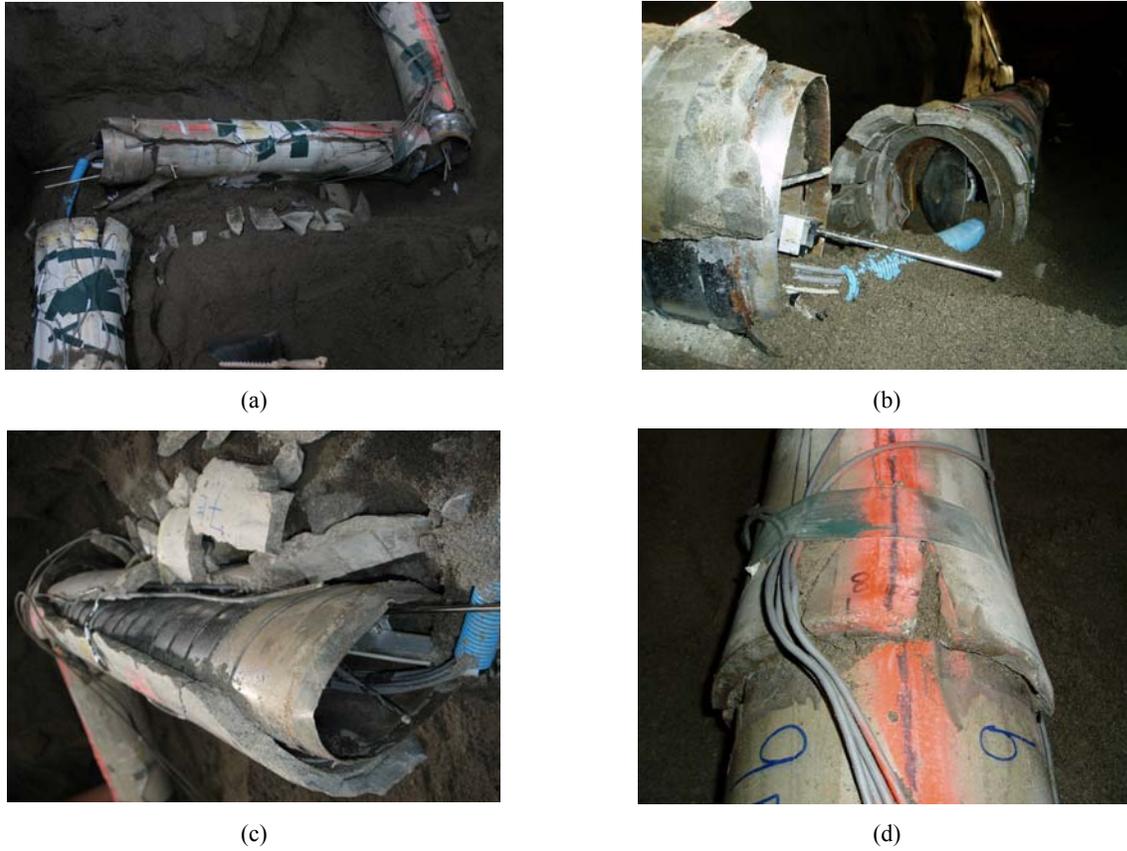
After the removal of the loose granular soil at the end of the test (Fig. 7a), the pipeline was visually inspected. Considerable damage was immediately witnessed in the vicinity of the fault plane. Specifically, the pipeline connection between segments #6 and #7 and segments #7 and #8 were evidently subjected to severe bending moment and axial force. Failure at these joints led to complete separation of pipe segment #7 from segments #6 and #8 (Fig. 7b). In addition, the severe shear force distorted the center pipe segment into an oval shape with the concrete wall completely spalled from the steel sleeve (Fig. 7c). The joint between pipe segments #8 and #9 also experienced some telescopic failure with the spigot telescoping into the bell of the adjacent pipe (Fig. 7d). The telescopic failure was attributed to

Fig. 7. (a) Excavated pipeline after PGD. Central pipe segment #7 was completely removed from segments #6 and 8. (b) The joint between segments #7 and 8 with LVDT needle evident. (c) Oval distortion of segment #7 due to extreme shear forces during PGD. (d) Telescopic failure at the connection between segment #8 and #9.

high compressive forces that developed during PGD. The portions of the pipeline away from the fault plane appeared undamaged which further supports the assumption that damage in the pipeline was largely localized to the center pipe segment crossing the fault plane.

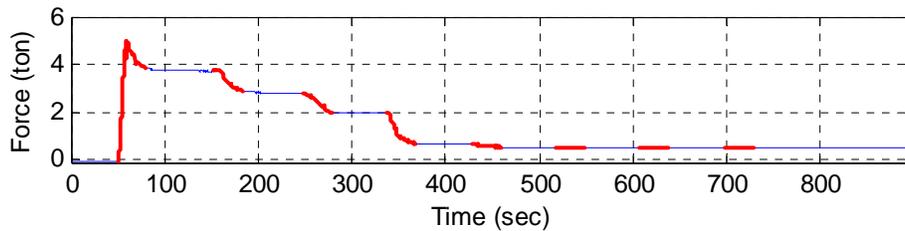
Fig. 8. Axial force measured at the southern end of the test basin. A noticeable reduction in the axial force is witnessed 8 sec into the first actuation step (corresponding to a displacement of 5.2 cm on the fault plane).

The concrete segmented pipeline was subjected to flexural bending and axial compression during the early stages of actuation. The axial compressive force (Fig. 8) measured at the southern end of the pipeline grew rapidly until a sudden drop was witnessed at about 8 seconds into the first displacement step. This distinct change in axial force measured at the end of the pipeline corresponded to a PGD of 5.2 cm. The sudden drop in axial force suggested severe structural damage along the pipeline; the most likely cause was the damage withstood by pipe segment #7 including cover spalling and destruction in the vicinity of the segment's joints. Investigation of the actuation force (Fig. 6) corroborates this

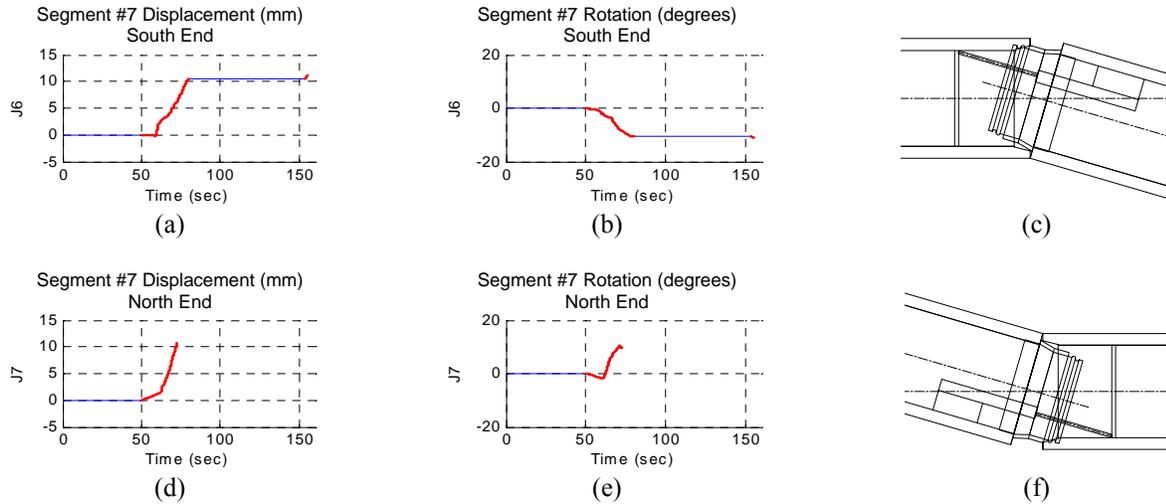
Fig. 9. Response of pipe segment #7: (a) south-end displacement; (b) south-end rotation; (c) LVDT at the limit of its measurement range at the southern-end; (d) north-end displacement; (e) north-end rotation; (f) LVDT at the limit of its measurement range at the northern-end.

Investigation of the LVDTs at the ends of the pipe segments further revealed the behavior of the pipeline during the first actuation step. The majority of instrumented connections showed negligible displacement and rotation during loading. Only three connections revealed noteworthy deformation during fault displacement. For example, the displacement and rotation of the southern and northern joints of pipe segment #7 during the first actuation step are presented in Fig. 9. Only LVDT measurements from the first actuation step were reliable due to the LVDT needles coming to the edge of the Lucite plates toward the end of the actuation step (Fig. 9c and 9f). The final rotation at the south- and north-ends of pipe segment #7 was 11.6° and 10.5° , respectively, while the axial compressive displacement was 10.8 and 10.2 mm, respectively. The joint between pipe segment #8 and 9 also experienced 2.5 mm of compressive displacement and a modest rotation of 3° ; this was the joint with telescopic damage.

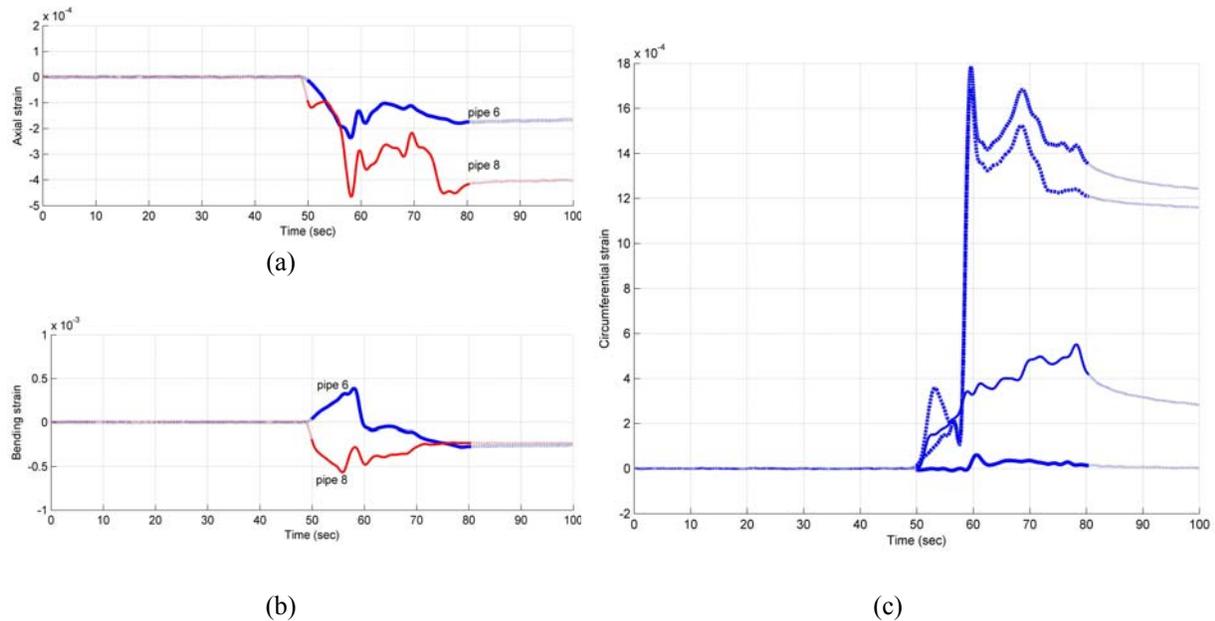
The strain gauges in the center of pipe segments in the vicinity of the fault plane provided additional insight to the behavior of the pipeline during the first actuation step. As shown in Fig. 10, the axial strain (calculated from an average of the top and bottom strain gauges) and bending strain (calculated as the difference between the two strain gauges on the side of the segments) of pipe segments #6 and #8 are plotted. The strain time histories revealed that both pipe segments were subjected to axial compression and flexural bending. However, there was a sudden spike and drop roughly 6 seconds into the first actuation step suggesting structural damage somewhere along the pipeline. A similar trend was also found in the circumferential strain measured at the bell-end of pipe segment #6 (Fig. 10c). The circumferential strain grew steadily until about 8 seconds into the first actuation step when many of the gages suddenly jumped to large levels of strain ($1800 \mu\epsilon$) and then settled down to a residual level of $1200 \mu\epsilon$. This behavior is consistent severe cracking near the circumferential strain gauges at the connection between pipe segments #6 and #7.

Fig. 10. Pipeline strain response during the first actuation step: (a) axial strain of pipe segments #6 and #8; (b) bending strain of pipe segments #6 and #8; (c) four channels of circumferential strain measured at the bell-end of pipe segment #6.

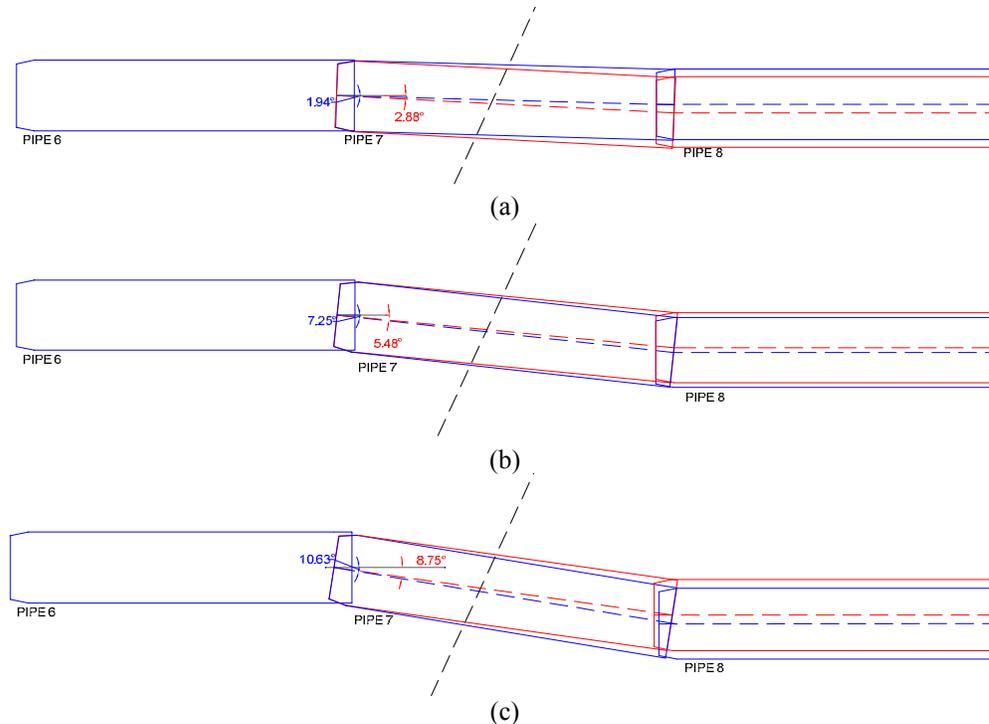
Fig. 11. Tracking the movement of pipe segments #6, #7 and #8 during the first actuation step: (a) 10 seconds, (b) 20 seconds, and (c) at the instant of reaching the sensing limit of the LVDTs.
