Behavior of full-scale concrete segmented pipelines under permanent ground displacements

Keywords: pipelines, concrete segmented pipe, permanent ground displacement, full-scale test, earthquake engineering

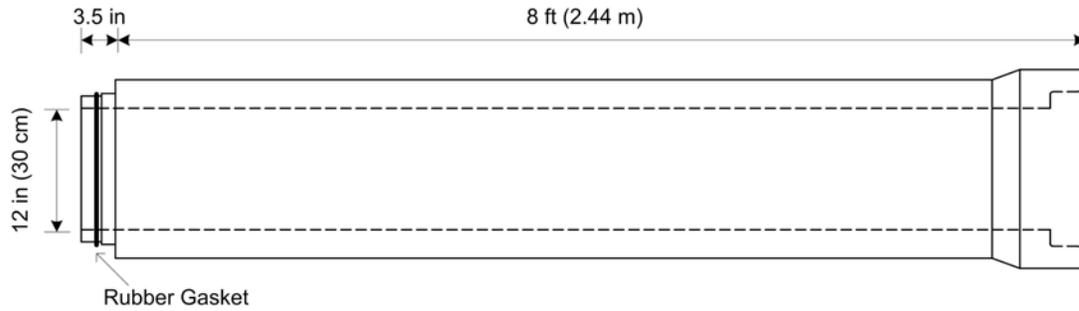
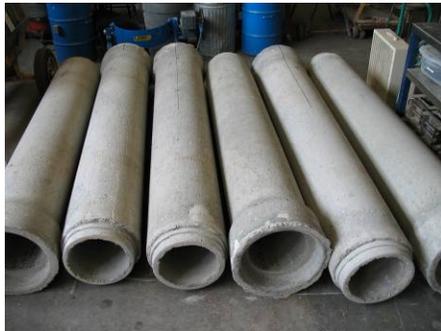
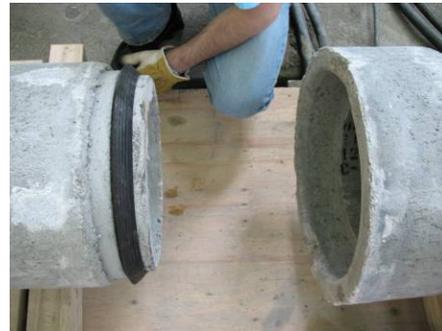
Fig. 1. Reinforced concrete segmented pipe: (a) pipe segment geometry; (b) pipe segments upon delivery at the NEES-Cornell facility; (c) close-up view of an open bell-spigot connection with a rubber seal evident on the spigot end of the left-most pipe.

A full-scale, 12 inch (30.48 cm) diameter commercial reinforced concrete pipe (Class 3/4) was selected as the pipeline specimen for this study (Fig. 1). The pipe was manufactured by Hanson, Inc. (Rhode Island) according to ASTM C 76 [11] and C 655 [12] specifications. The full-scale pipe was 8 ft (2.44 m) long and approximately 900 lb (408 kg) in weight. The pipe cross-section consisted of a 12 inch (30.48 cm) inside wall diameter with a 2.38 in (6.3 cm) wall thickness. The pipe walls were reinforced with steel bars using a reinforcement ratio of 0.07 (in²/linear ft). The compressive strength of the concrete material was tested to be 4000 psi (27.58 MPa).

The pipe joints are the classical bell-spigot joint type. A rubber gasket was placed near the spigot end to ensure a snug bell-spigot connection and to seal the joint during assembly of the pipeline. In total, six pipe segments were shipped to the NEES Lifeline Experimental and Testing Facility at Cornell University where they were assembled into a complete segmented pipeline consisting of 5 full segments and one partial segment (that was cut to size). Assembly consisted of fitting the spigot end of one pipe into the bell end of another. A wet grout containing 30% fine aggregate, a 0.5 water-to-cement ratio, and 0.5% high-range water reducer, was mixed and poured into the annular spaces of each bell-spigot connection accommodated by a thin plastic mold designed to hold the grout in the connection while setting.

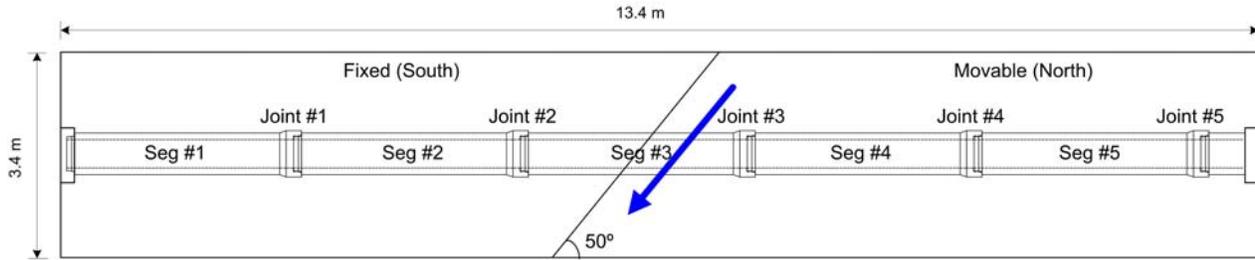
Fig. 2. Layout of the segmented concrete pipeline in the Cornell Lifeline Experimental and Testing Facility's test basin.

The Lifeline Experimental and Testing Facility at Cornell University contains a large test basin in which pipelines can be constructed and tested under PGD. The basin itself is a 3.4 m wide, 13.4 m long, and 2 m high box. The basin was designed to simulate a transverse fault oriented 50 degree relative to the longitudinal length of the basin as seen in Fig. 2. The north end of the test basin was attached to four hydraulic actuators for controlled displacement while the south end of the basin was held fixed. The test basin was filled with one initial layer of soil, approximately 20 cm deep, to create a bed for the pipeline to be installed on. After being instrumented with various sensors, the pipe segments were lifted by crane into the test basin and installed, beginning at the south end (Fig. 3a). Each time a pipe segment was laid into the basin, wiring for the sensors was fed through the inside of the pipe or arranged along the outside of the pipe, depending on the location of the sensor. The final segmented concrete pipeline consisted of five full pipe segments in addition to a sliced pipe segment installed at the north-end of the basin (Fig. 2). The pipeline was fixed at both ends of the test basin using steel plates. The center pipe segment (designated as pipe segment #3 in Fig. 2) crossed the 50 degree transverse fault. This fault geometry would place the pipe in a state of compression during PGD.

The strain gage data provided additional information on the behavior of the pipeline (Fig. 12). The axial and bending strain at three equidistant points along pipe segments #1, #2, and #3 (Fig. 2) are depicted in Fig. 12. For the case of segment #3 (*i.e.*, the center pipe), the first strain gage pair did not work during the test. Generally, the increase in axial strain observed in each pipe segment was found to be proportional to each actuation step. However, depending on the stage of the test, the bending direction changed at each pipe segment.

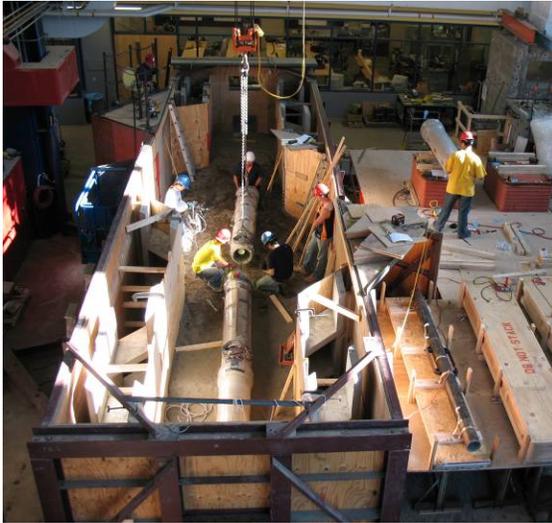
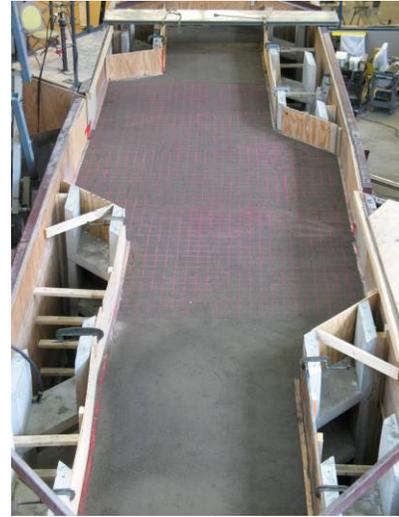
Fig. 3. (a) Installation of the instrumented pipe segments in the test basin; (b) test basin fully backfilled with compacted granular soil (prior to testing).

After all pipe segments were laid, the joints of the pipeline were wrapped with a plastic mold and grouted. Granular soil was backfilled into the test basin to bury the pipeline roughly 140 cm beneath the soil surface. Backfilling of the test basin was conducted one layer at a time with each layer 20 cm deep. Once a layer of soil was placed in the basin, it was compacted according to field construction practice. During the backfilling stage, a nuclear density gage was used to repeatedly measure the density and water content of the soil; a relatively constant density (1.7 Mg/m^3) and water content (5%) was observed throughout the soil column. After backfilling (Fig. 3b), a grid was laid on the surface of the soil to aid in visually observing disturbances to the soil surface during PGD.

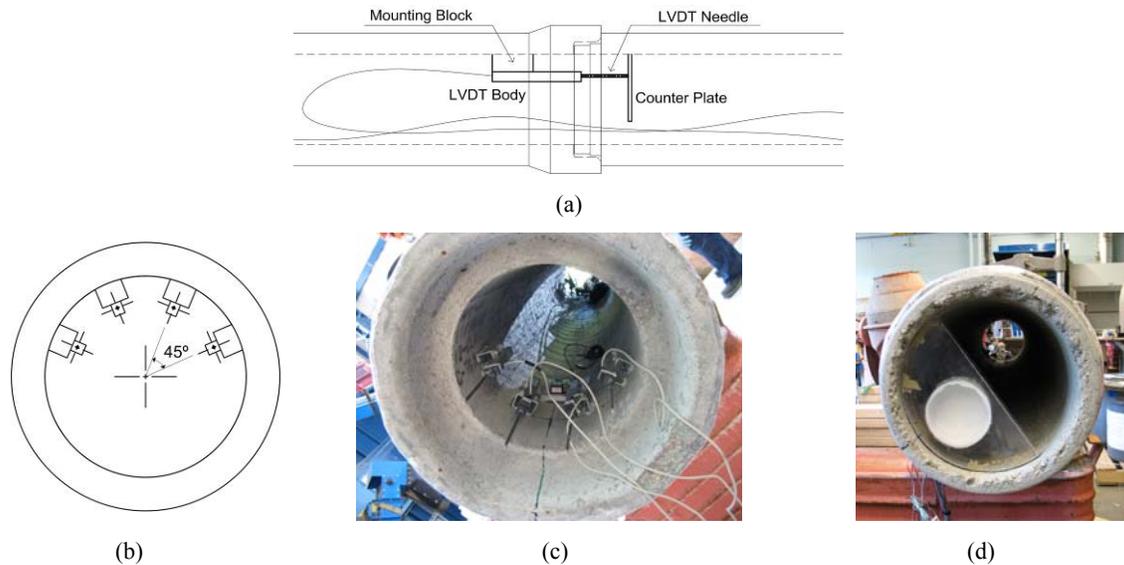
Fig. 4. (a) Schematic of a LVDT installation at a typical joint; (b) A set of four LVDTs at upper part of pipe cross section; (c) Four LVDTs mounted on C-channel blocks on the interior of the pipe near the bell; (d) A dichotomy-shaped Lucite plate mounted in the spigot.

A dense array of sensors was installed throughout the buried segmented concrete pipeline in an effort to monitor deformation and failure modes during PGD. An elaborate instrumentation plan was followed to measure translational and rotational movement of the segmented pipeline joints. Four sets of four linear variable differential transducers (Novotechnik TR100 LVDT) were installed at joints #1 through #4, totaling 16 LVDTs for the complete pipeline. As shown in Figs. 4a and 4b, four LVDTs were installed along the upper, inner surface of the pipe. The LVDTs were installed on C-channel blocks, roughly 3 cm tall, in order to allow more spacing between the LVDT needles and the pipe wall. The C-channel mounting blocks were epoxy set to the concrete roughly 45 degrees apart from one another. LVDT needles protruding from the bell end of one pipe joint are designed to make contact with a Lucite plate (Fig. 4d) epoxy mounted inside of the spigot end of the adjacent segmented pipe. Shielded coaxial wiring from the LVDTs are strung through the interior of the pipeline. The LVDT wires are brought outside of the basin through an opening in the basin wall near the location where the pipeline is mounted.

The LVDTs installed in each joint are designed to directly measure joint translation and rotation along the length of the pipeline. A specific plane is geometrically determined in three-dimensional space using the coordinates of 3 points located on the plane. Thus, three LVDTs can be used to determine the orientation of the Lucite plate (plane); one of the four LVDTs is designed to be redundant and can be used if one LVDT is found to not be operating properly during the test. Using the coordinate system established in Fig. 5 (where the z-axis is oriented in the direction of the LVDT

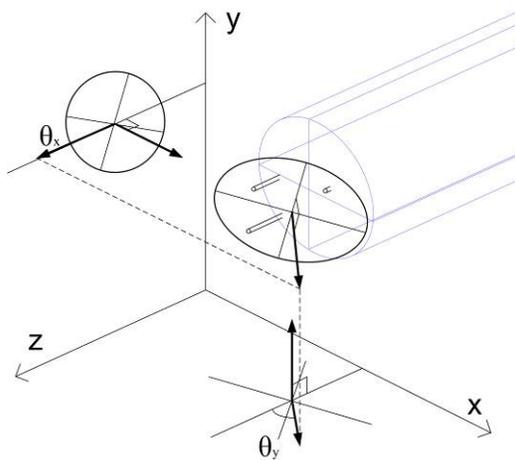
Fig. 5. Geometric interpretation of joint rotations from three LVDT measurements. The center ellipse stands for the plane determined by three LVDTs; The normal vector for the plane is projected on x-z and y-z plane.

needles), two rotational angles along the x- and y-axes (representing the vertical and horizontal rotations of the pipe segment) are calculated by projection of the plane vector onto the x-z and y-z planes. Movement along the z-axis, which represents the axial translation at the joint, can be also calculated by averaging the change in length of three LVDTs.

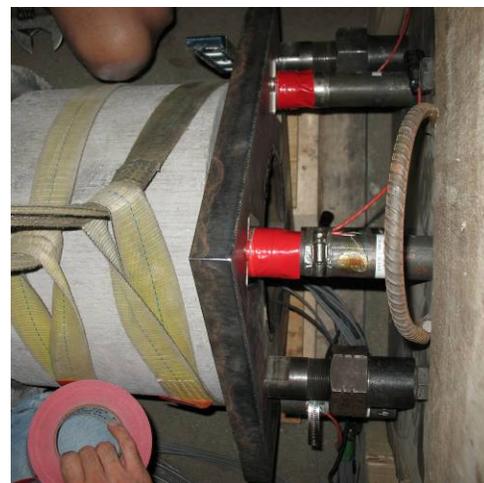
Fig. 6. Four instrumented load cells at the ends of the pipeline.

At each of the two ends of the pipeline, four load cells were installed to measure the axial force imparted by the test basin during compression deformation of the pipeline. Each load cell consists of a steel annulus instrumented by a rosette strain gage array which are interfaced with a half-bridge circuit in a National Instrument SCXI-1520 data acquisition system. Precise calibration tests for determining axial force from measured strain were conducted before the test.

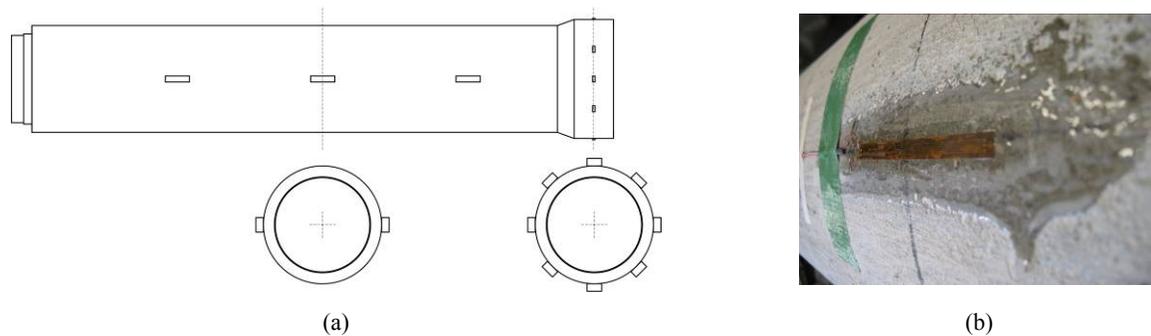
Fig. 7. (a) Installation of strain gages on the pipe segments. Axial strain measured on six strain gages mounted at the center of pipe segments. An additional 8 strain gages installed at the bell end of pipe segment #2 and #3 to measure hoop strain. (b) Strain gage mounted to the pre-coated layer on the surface of the concrete.

In addition to measuring joint movement, deformation along the pipe was also monitored using strain gages. Strain gages (Vishay N2A-06-40CBY 350 Ω metal foil gages) designed for measuring concrete strain on the surface of a concrete structure were mounted longitudinally along the length of the pipeline. The long gage length (101.6 mm) allows strain integration along non-homogeneous specimens. Strain gages were placed equidistant along the pipe length and on each side of the pipe segment as seen in Fig. 7a. These six strain gages allow for the measurement of both axial and bending strain at three sections of each pipe segment. Axial strain at a section is calculated by taking the mean of the two strain measurements. Similarly, flexural response of the pipe at a given section is calculated using the difference between the two strain gages. An additional 8 strain gages (Vishay L2A-06-250LW 350 Ω metal foil gages) were mounted circumferentially on the bells of pipe segments near the fault line, namely joints #2 and #3. These eight gages were installed to measure hoop strain at the pipeline connections. During installation of the strain gages, the rough concrete pipe surface was ground smooth and then a very thin and smooth surface epoxy layer was applied as seen in Fig. 7b. The epoxy layer was delicately cleaned by fine sand papers followed by additional cleaning using acid and base solution. Strain gages were firmly mounted above the smoothed epoxy surface using strain gage bonding adhesive.

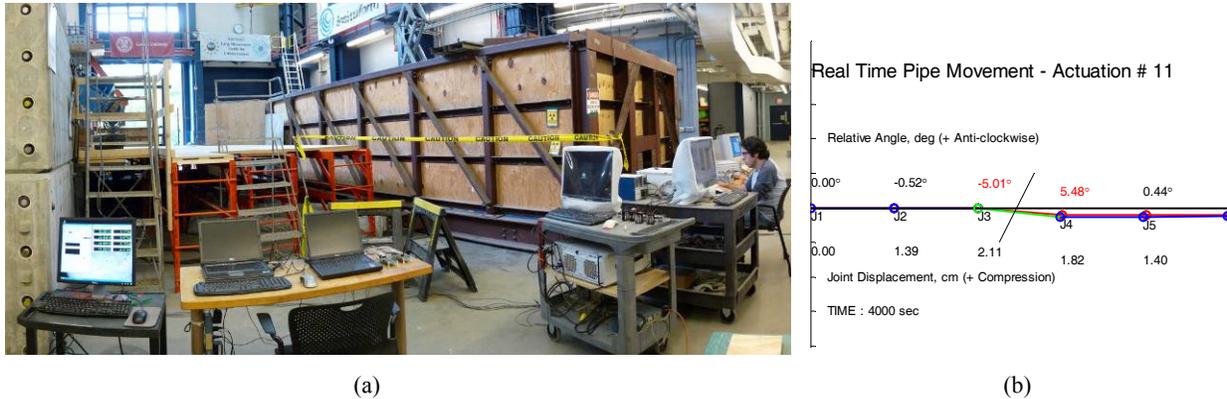
Fig. 8. Experimental setup: (a) data acquisition systems near the north test basin; (b) real-time pipeline movement after the 11th actuation step.

Two monitoring systems were used during testing. First, a National Instrument data acquisition system (Fig. 8a) was setup near both ends of the test basin to record data from the 16 LVDTs, 46 strain gages, 8 load cells, and 4 actuators (which output actuator displacement and force measurements). Considering the slow movement of the northern portion of the test basin, a modest sample rate of 10 Hz was utilized by the National Instrument data acquisition system. A second monitoring system was used during testing. The output of the 16 LVDTs was split so that it could be interfaced to wireless sensor nodes (termed *Narada*) under development for structural health monitoring at the University of Michigan [14]. The additional wireless monitoring system for the LVDTs was designed to provide real-time measurement of the pipe joint movements during testing. The LVDT data was sent by the wireless sensors to a wirelessly-enabled data sever which was setup to process and convert displacement measurements at each joint into pipe movement for online, real-time display as shown in Fig. 8b. This allowed the team to monitor the behavior of the buried

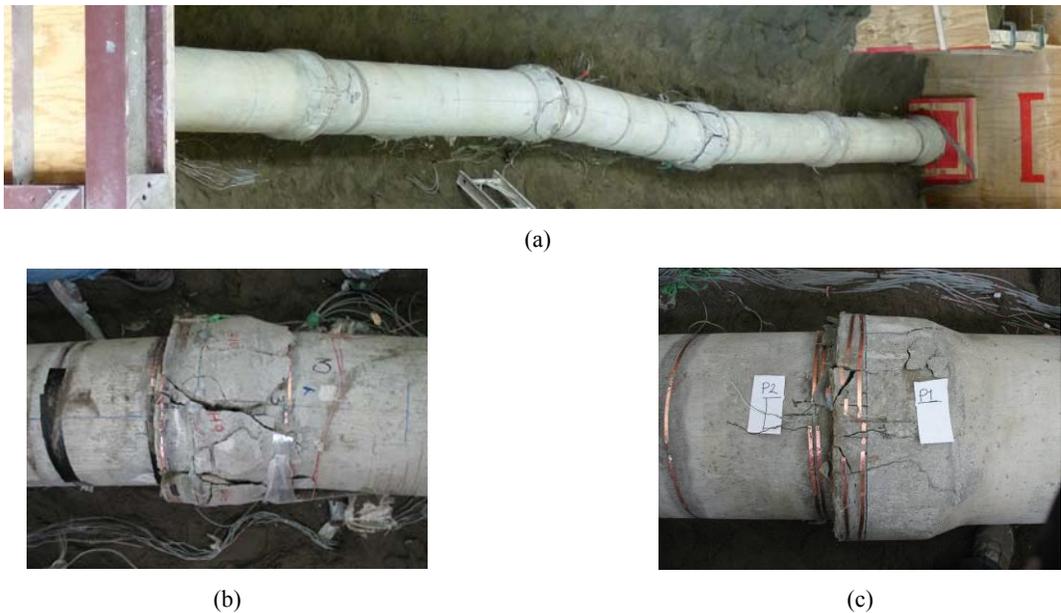
Fig. 9. (a) Excavated pipeline after the test. Two main failure modes were found: (b) Combined failure by rotation and contraction at two joints (#2 and #3) near the ground fault, and (c) compressive telescoping failures at the other joints (#1, #4, and #5).

After testing was complete, the soil above the pipeline was carefully excavated so as not to disturb the pipeline's deformed condition. As shown in Fig. 9a, the center pipe segment (segment #3) rotated to accommodate the applied PGD. Thus, considerable damage was immediately witnessed in both segment joints (joint #2 and #3). Besides rotations,

approximately 1 inch-long spigot telescoping was witnessed with the spigot of segments compressed into the bells of the adjacent pipe. Large portions of the concrete cover were spalled from the bell as seen in Fig. 9b. It can be speculated that these damage modes are due to a combination of failure mechanisms due to rotation and contraction. Other joints also experienced some telescopic damage (Fig. 9c), but not as severe as that of the two center joints (joint #2 and #3). The minor telescopic damage observed in joints #1, 4, and 5, and the severe damage encountered in joints #2 and #3 suggest strong soil-pipe interaction along the entire pipeline, which can be explained by the relatively high flexural rigidity and axial stiffness of the pipeline compared to the stiffness of the surrounding soil. No damage was found within the pipe bodies throughout the entire pipeline.

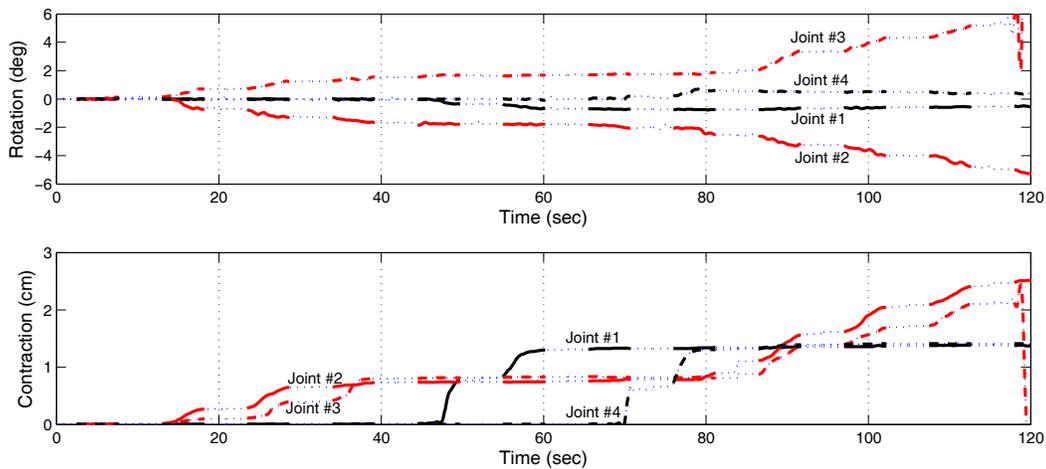
Fig. 10. Joint rotation (top) and contraction (bottom) at joints #1 through #4.

The behavior of full-scale concrete segmented pipelines under PGD was thoroughly investigated by analysis of the data collected from the test. First, investigation of joint rotations and contractions, which were processed from the LVDT's, revealed generic failure behavior of the concrete segmented pipeline. Fig. 10 plots the measured joint movement at joint #1, 2, 3 and 4 over the duration of the test. Strong axisymmetric behavior was observed with respect to the pipeline center. As actuation steps proceeded, significant rotations (5.7°) occurred at joints (joint #2 and #3) close to the fault plane compared to small rotations (0.6°) at joints #1 and #4 which are close to the pipeline ends. However, significant joint contractions (ranging from 1.3 to 2.5 cm) happened at every joint due to fairly uniform axial compression along the pipeline length. The results obtained can explain the aforementioned joint failure modes, *i.e.*, combined rotation and contraction failures at the center of the pipeline but compressive telescoping failures away from the fault plane.

A detailed stepwise interpretation of the results explains the possible failure sequence of the pipeline joints. During the first 2.5 cm of displacement (termed actuation step A#1), no significant movement was found at any joint, which implies that the pipeline structure behaved linearly under PGD. However, joint failures occurred in the actuation sequences that followed. Rotation and contraction were monitored at the two joints near the fault line (*i.e.*, joint #2 and #3) from A#2 through A#4. Following that, joint #1 was damaged from A#5 and A#6 while joint #4 was damaged from A#7 to A#8. During these stages, no more significant movement was found at joint #2 and #3. From actuation step A#9 until the final actuation step (A#12), joint #2 and #3 experienced severe contraction and rotation, resulting in the crushing of the grout and spalling of the concrete cover. As the grout crushes, adjacent pipe segments come into direct contact effectively increasing the flexural rigidity and axial stiffness of the pipeline. This is different from a situation where the pipeline is fully broken into articulated segments.

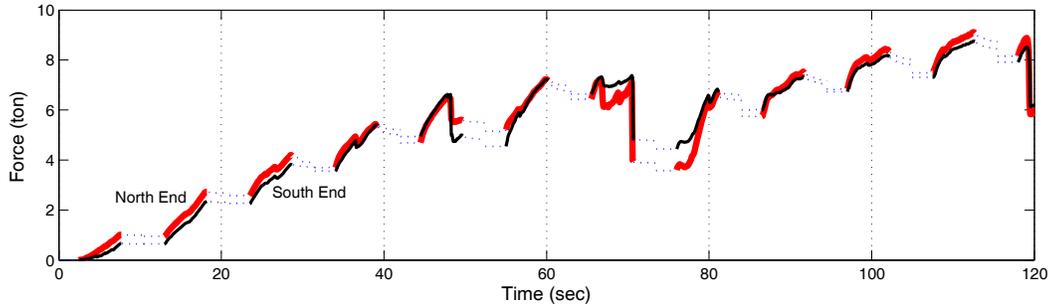
Fig. 11. Axial forces at the end of the pipelines measured by load cells.

Investigation of the axial compressive forces (Fig. 11) measured at both ends of the pipeline also support the aforementioned interpretation of the pipeline behavior. During the test, the pipeline underwent strong axial force due to the geometry of the fault line. Similar compressive forces were monitored at both ends of the pipe through 12 actuation

steps as seen in Fig. 11. As the ground displacement proceeded, the pipeline end forces also increased. However, three sudden drops of end force were found at both ends during actuation steps A#5, A#7, and A#12. During step A#5 and A#7, joint #1 and #4 started to undergo damage (likely telescopic-type damage) thereby releasing axial force along the pipeline. A sudden drop of end force at A#12 reflected the sudden introduction of severe damage along the pipeline. It should be noted that no significant end force drop was monitored at A#2 and A#3 when joint #2 and #3 were damaged. This can be explained by soil friction around the pipeline; at the early stage of the test, soil disturbance was not severe and the two joints were more than 5 meter apart from each end.

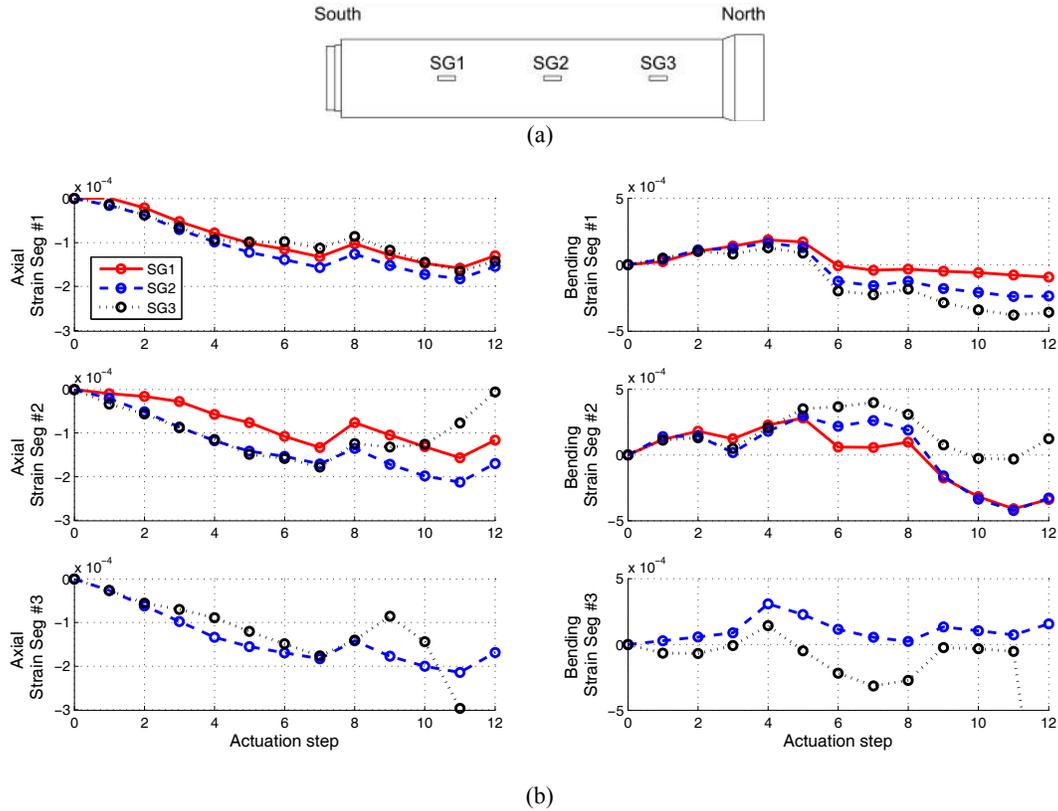
Fig. 12. (a) Strain gage locations; (b) axial and bending strain for three pipe segments (segments #1,#2, and #3).
