105 Series Alfa Fuel Tanks

By John Hoard

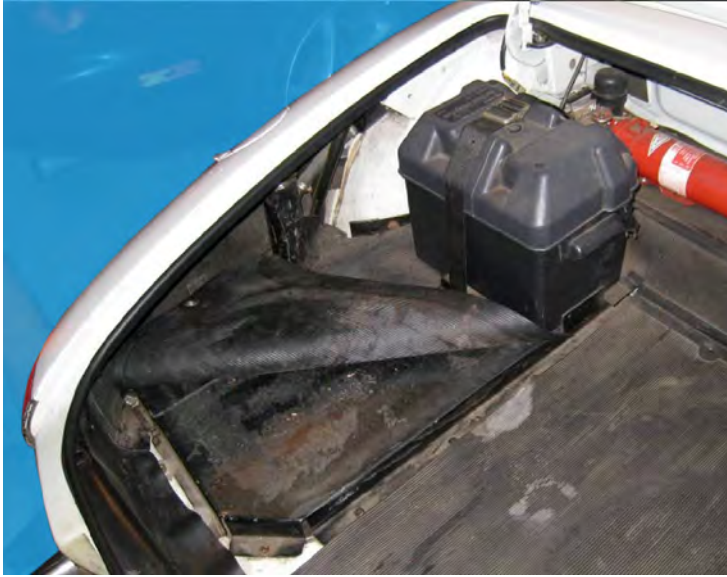
Spider fuel tank area. Note battery mounted to reinforcement.

On the Spider, I moved the battery to the trunk, and while looking for a good way to mount it Dean Russell suggested adding in the fuel tank reinforcement from a later Alfa. Late in the life of the 105 series, rear impact standards came in. Part of Alfa's answer was a thick metal reinforcement that goes over the fuel tank in the trunk. Again, it helps transfer loads in a crash and protects the tank. It also makes a good strong surface to mount a rear battery!

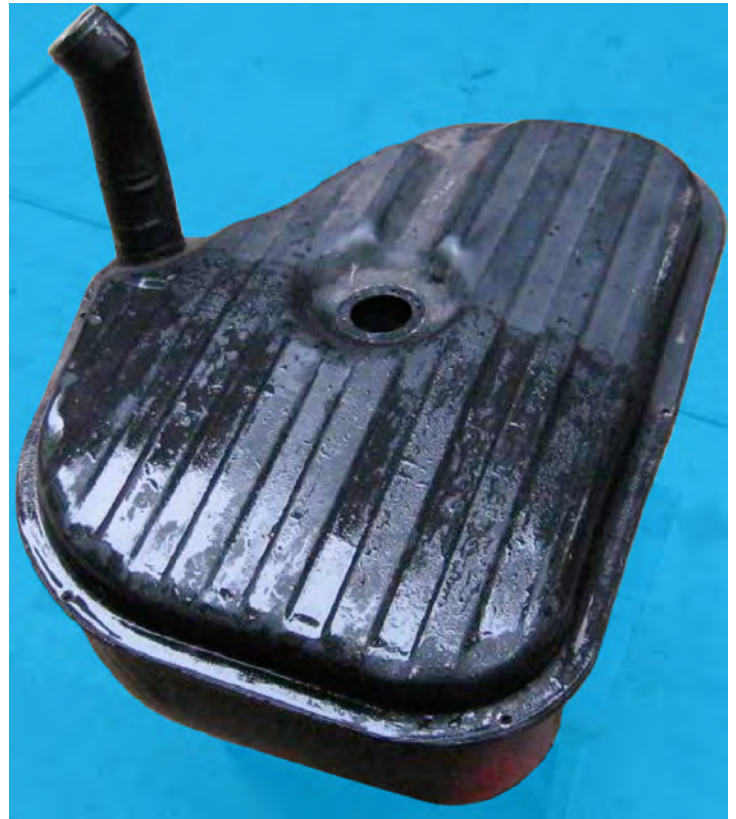
GTA fuel tank, out of the car

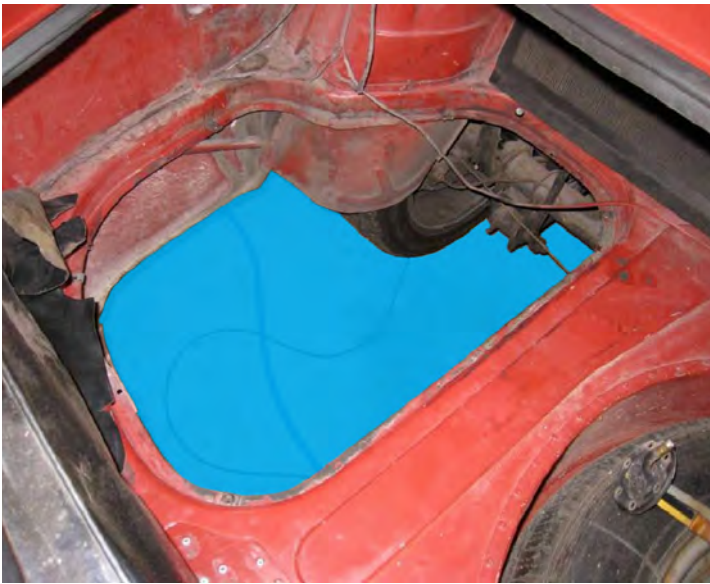
Where the GTA fuel tank resides

Nonetheless, gasoline is a flammable liquid, and leaks can be a problem. In more modern cars, fuel tanks are carefully mounted mid-ships, often under the rear seat and always with floor pan sheet metal between you and the tank. In older cars including 105 series Alfas, the tank was most often “drop in” – dropped into the trunk floor through an opening, with a flange on the tank to keep it from falling through. Thus, the top of the tank is in the trunk. It is also behind the major vehicle structure, being

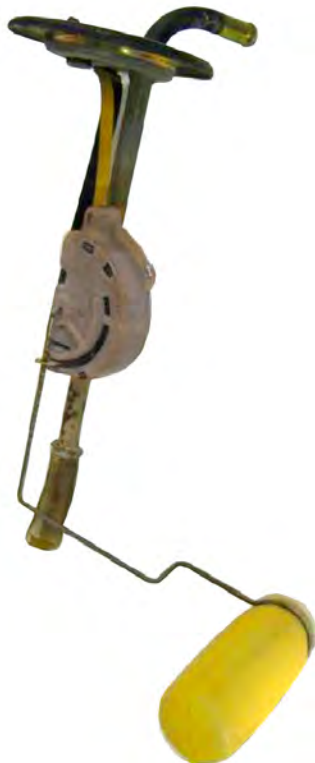
Fuel sender from GTA

The driver may also have some slight interest in knowing how much fuel is in the tank. The sender assembly shown in the picture is typical for pre-injection cars. You can see the pick up tube and inlet screen, and a float connected to a potentiometer. As the fuel level drops, the float drops and the gas gauge goes down. If your gauge is really inaccurate, you can try bending the rod and see if you can get better accuracy.

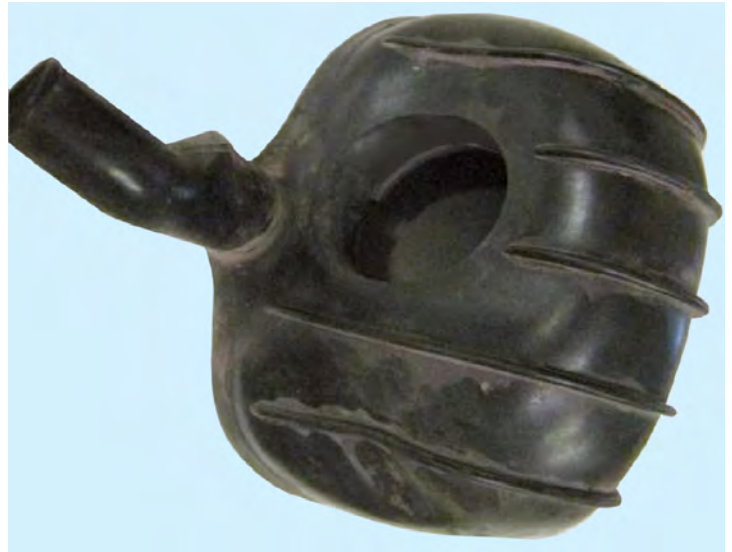
Rubber boot; the fuel filler goes through the big hole. The tube goes through the trunk floor to drain refueling spills.

Once empty, disconnect the hoses and wires, remove the fill cap (put a paper towel in to keep crud from finding its way in, or perhaps tape it over). There is a large rubber boot around the filler neck. Unsnap it from the fender, pull the drain out of the floor, and work it off the filler neck. This is lots of fun, especially since the rubber is now nice and old and rock hard. You might be able to get the tank out with it in place but not me!
